On April 20, 2002, 1st Battalion, 2nd Aviation Regiment, Camp Page, Korea, experienced a potentially catastrophic inflight event while conducting AH-64D aerial gunnery operations. As the aircraft maneuvered into firing position, it began an uncommanded right yaw. Confirming that the turn was not copilot/gunner-induced and that neither station could move the pedals, the crew determined that they were experiencing a fixed-pitch

Boeing's on-site field support representative issued a "flash mishap report," which described the incident and its suspected root cause. At the Boeing Mesa facility in Arizona, all production line aircraft were immediately inspected. The inspection results were noteworthy for several reasons. First, it was determined that the jumper cable routing was clearly problematic

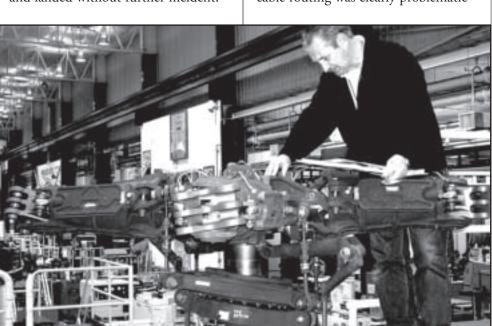
All SOF inspections are covered by this enhanced approach to quality assurance surveillance.
